# Crane Inspection Report

## GCD15

- Inspection Date : 17th November 2023.
- Model No. : GCD15
- Serial No. : 322924
- Operation Hours : 131 Hours
- Manufactured date : Jan 2023

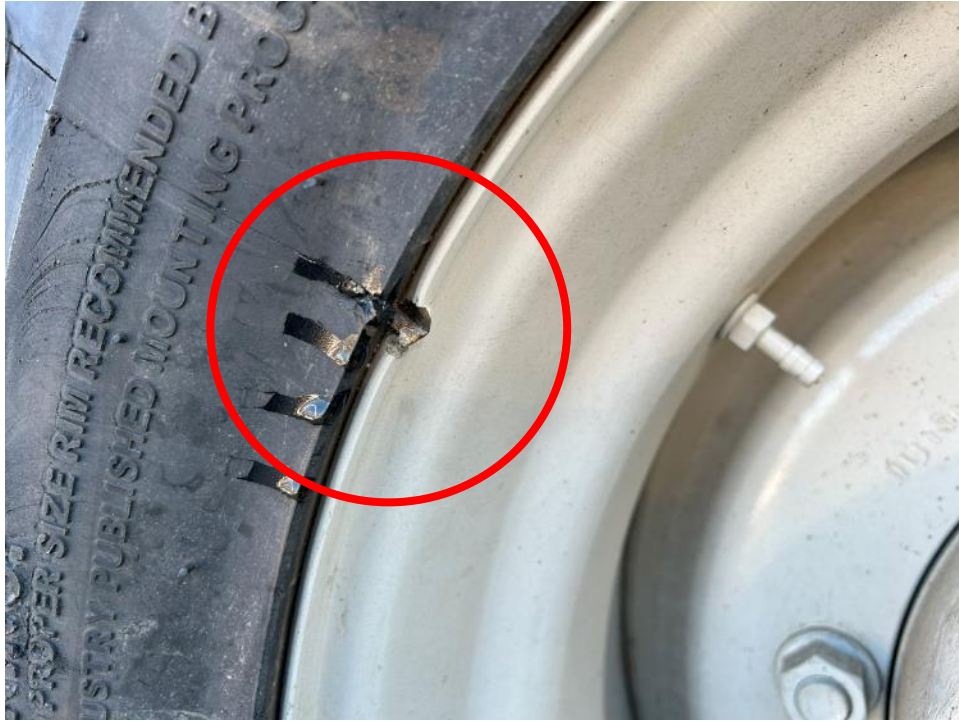
LH Front Wheel – Small Dent, no air leak.

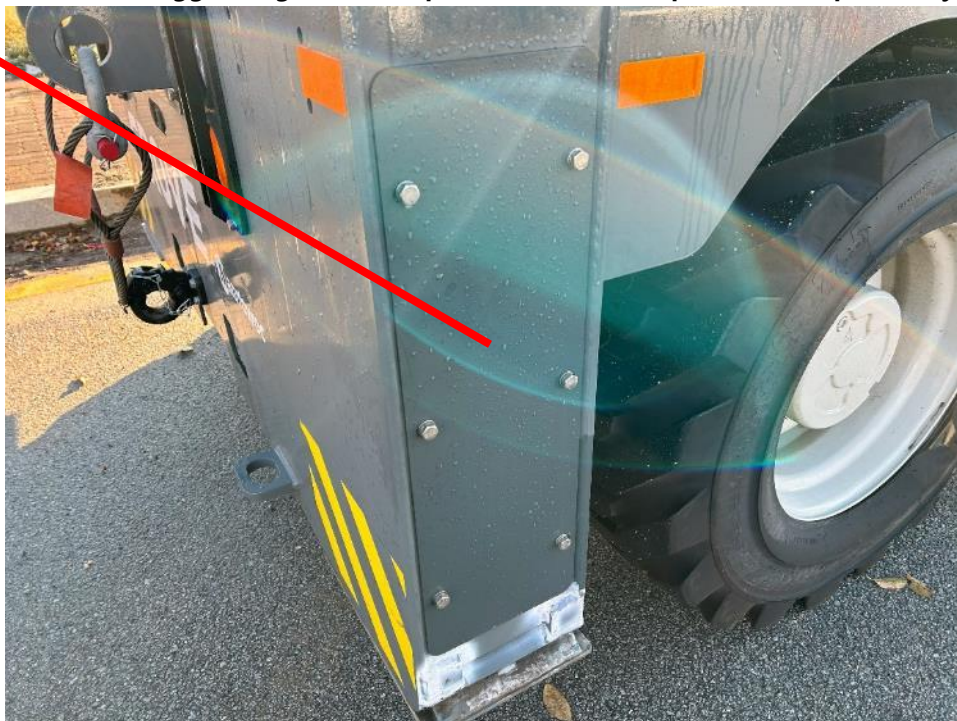
Replaced Part – LH front outrigger original cover plate dented. local produced, replaced by customer.

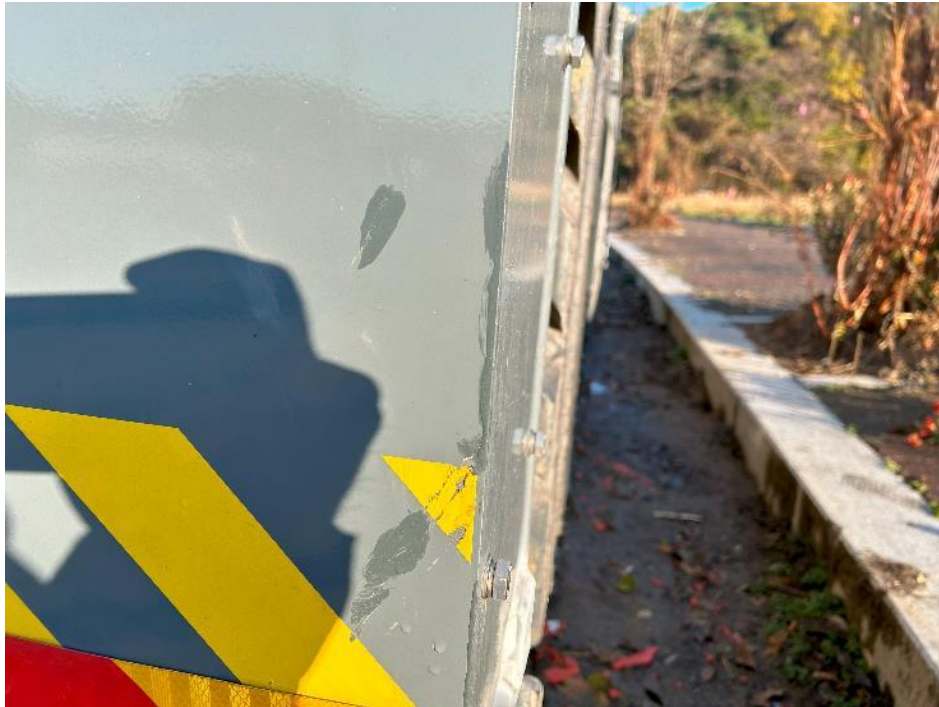
Minor Paint Scratches – touch up covered.
